# **EXPERIMENTAL ELECTRIC MOOSE FENCE STUDY**

## **Measures to Reduce Moose-Vehicle Collisions in Northeast New Brunswick**

**2000 - 2003**

**JUNE 2005**

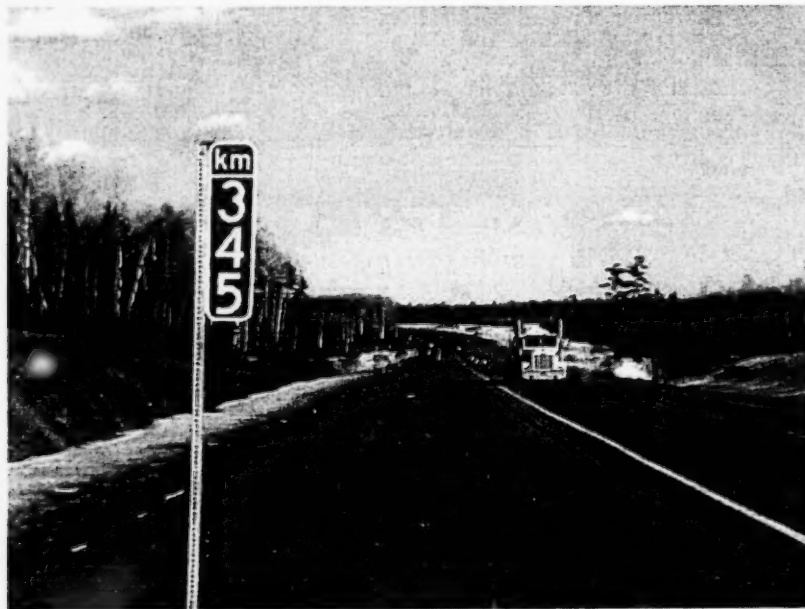
Figure 6. Mileage [kilometer] marker installed along Route 11 near Belledune NB for the purpose of obtaining from motorists precise locations of wildlife activity.

**Highway Mileage Markers -** For the public to report reliable locations of moose activity along the project route, it was considered necessary to establish visible kilometer markers along the highway. NB DOT had been planning to erect mileage markers along several highway alignments throughout New Brunswick and agreed to develop and install markers at 1-km intervals throughout the study area for this project. Figure 6 shows an example of the type of location markers used along Route 11 near Belledune, NB.

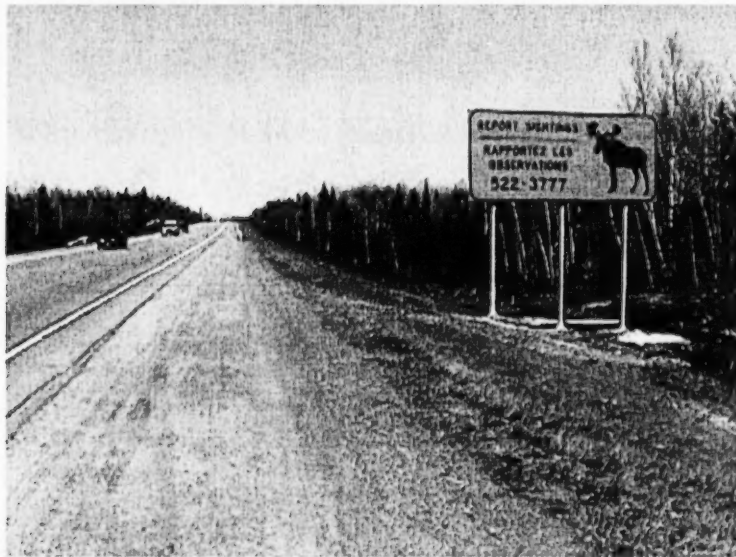
Figure 7. Bilingual sign identifying the telephone number that motorists could use to report moose activity at the entrance of the West Control Zone, Route 11, Belledune, NB.

and accurately report moose sightings within the study zone. With the growing use of cellular telephones by motorists, it was decided that signs could be erected that clearly identified a telephone number that could be used to report moose sightings. DOT designed and erected two large signs along Route 11, one at both approaches to the “control” zones [Figure 7]. These signs had a simple and clearly visible bilingual message: “REPORT SIGHTINGS--- RAPPORTEZ LES OBSERVATIONS 522-3777”, as well as incorporated a large silhouette of a bull moose.

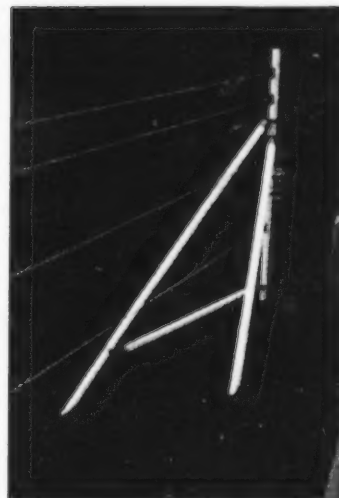
Figure 9 b. End post of moose fence installed next to the highway guard rail, Belledune River, Route 11, NB.
